Big Sand Lake

Vilas County, Wisconsin

Comprehensive Management Plan

May 2017

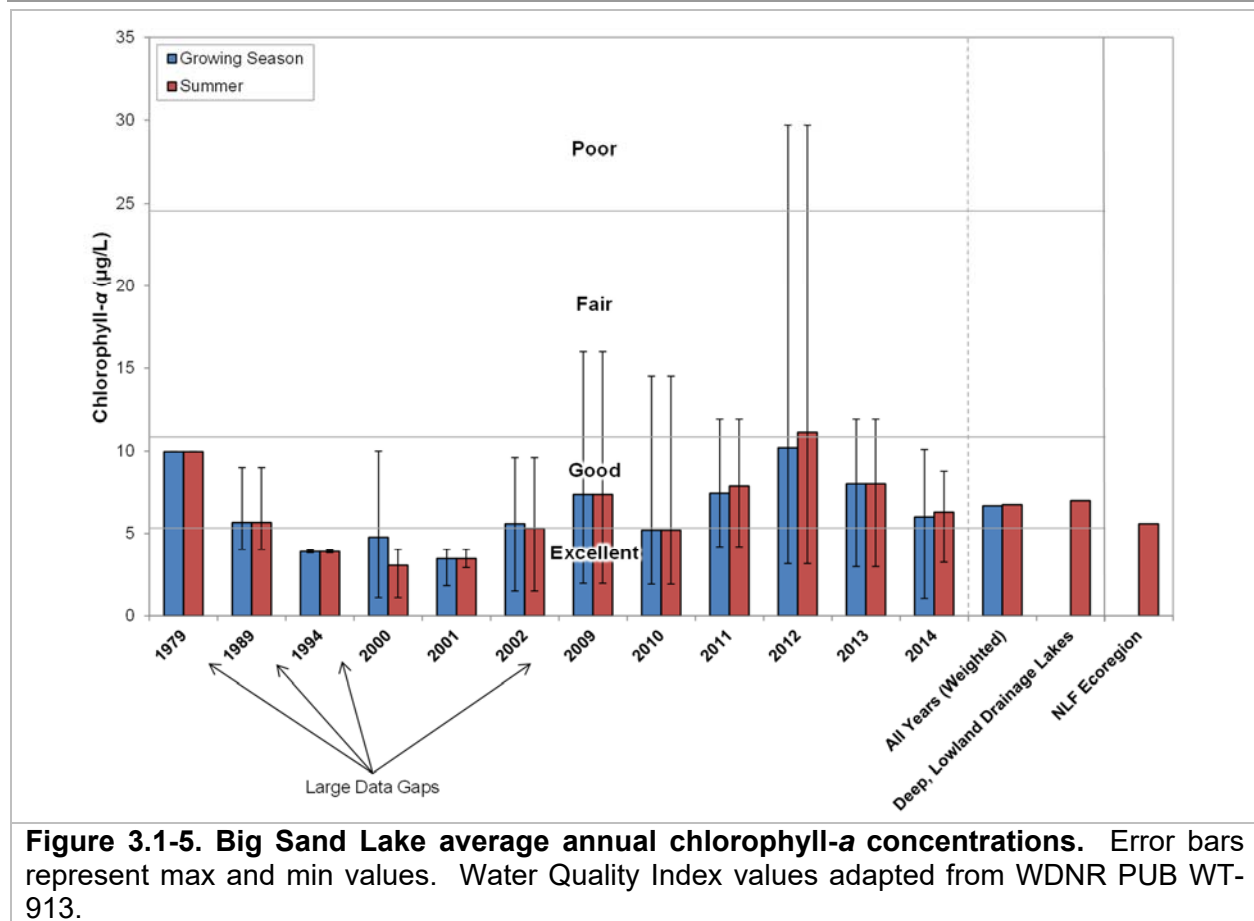
Figure 3.1-5. Big Sand Lake average annual chlorophyll-a concentrations. Error bars represent max and min values. Water Quality Index values adapted from WDNR PUB WT-913.

Chlorophyll-*a*, like total phosphorus, has been periodically measured since the 1970s and annually since 2009 (Figure 3.1-5). Concentrations of chlorophyll-*a* are relatively variable within the lake from year to year, spanning the *excellent* to *fair* thresholds. Chlorophyll-*a* concentrations in 2012 were the highest recorded within the available dataset, and were nearly twice as high as those recorded in 2014. The growing season of 2012 was markedly warmer and longer than average, and the longer period of warmer water temperatures likely fueled higher levels of algae growth. Overall, the weighted summer average chlorophyll-*a* concentration for all years data are available falls within the *good* category for deep, lowland drainage lakes, and is comparable to the median value for other deep, lowland drainage lakes throughout Wisconsin and slightly higher than the median value for other lakes within the Northern Lakes and Forests ecoregion.

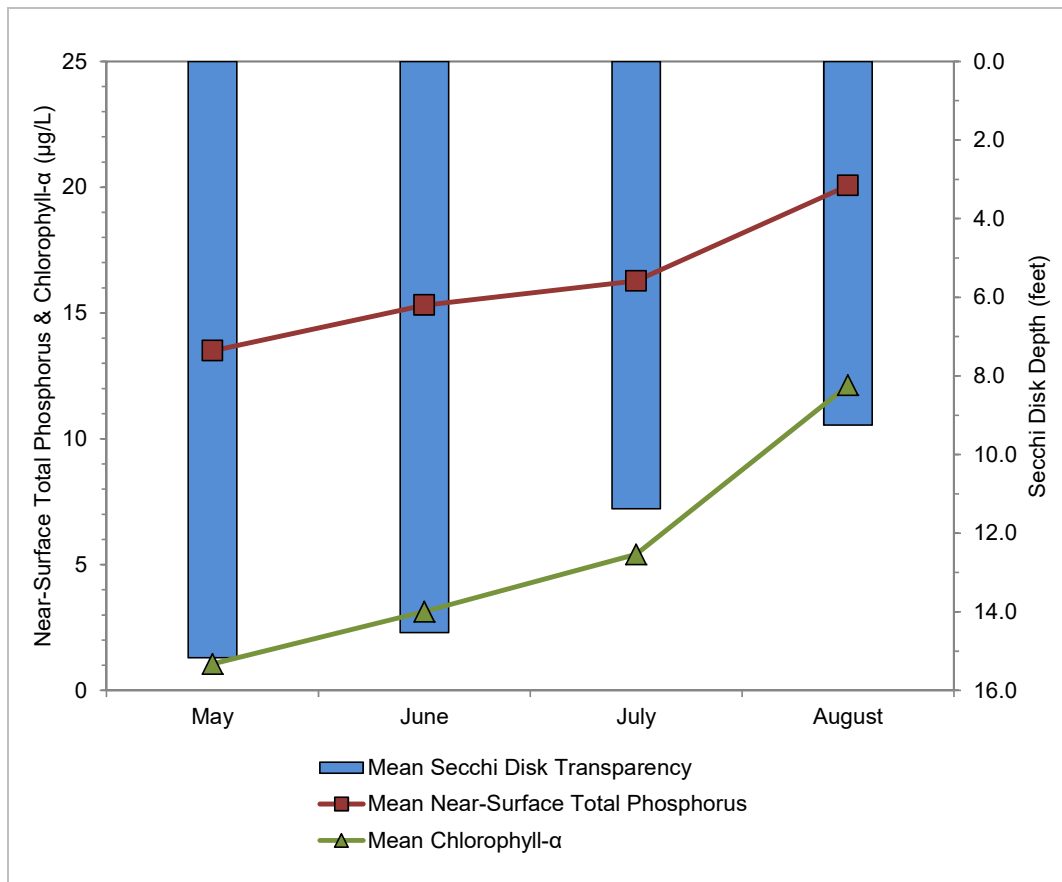
Figure 3.1-7. Big Sand Lake May-August monthly average Secchi disk transparency, near-surface total phosphorus, and chlorophyll-a. Data collected from historical records (WDNR SWIMS) and Onterra 2014 sampling.

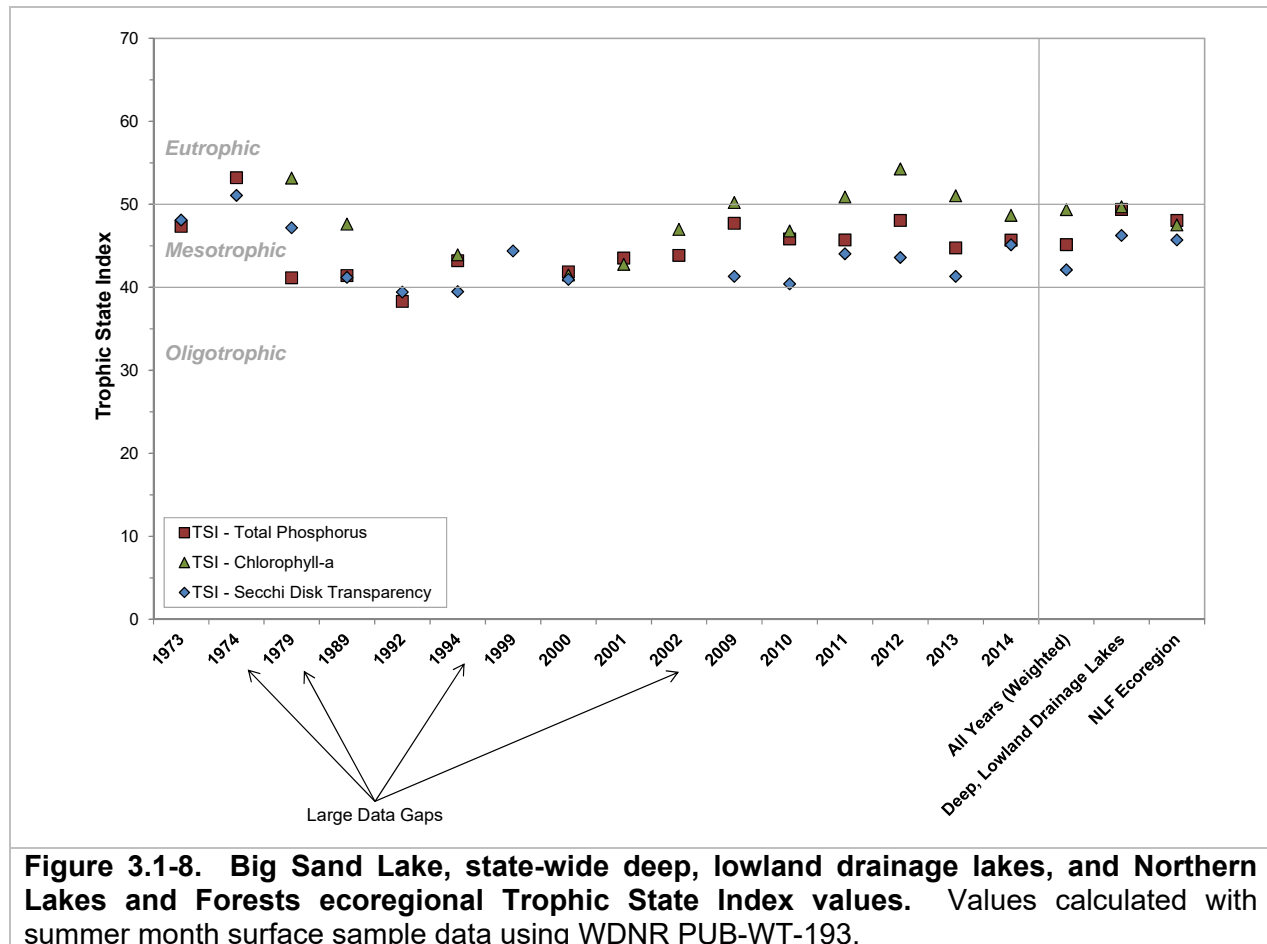
Figure 3.1-8. Big Sand Lake, state-wide deep, lowland drainage lakes, and Northern Lakes and Forests ecoregional Trophic State Index values. Values calculated with summer month surface sample data using WDNR PUB-WT-193.

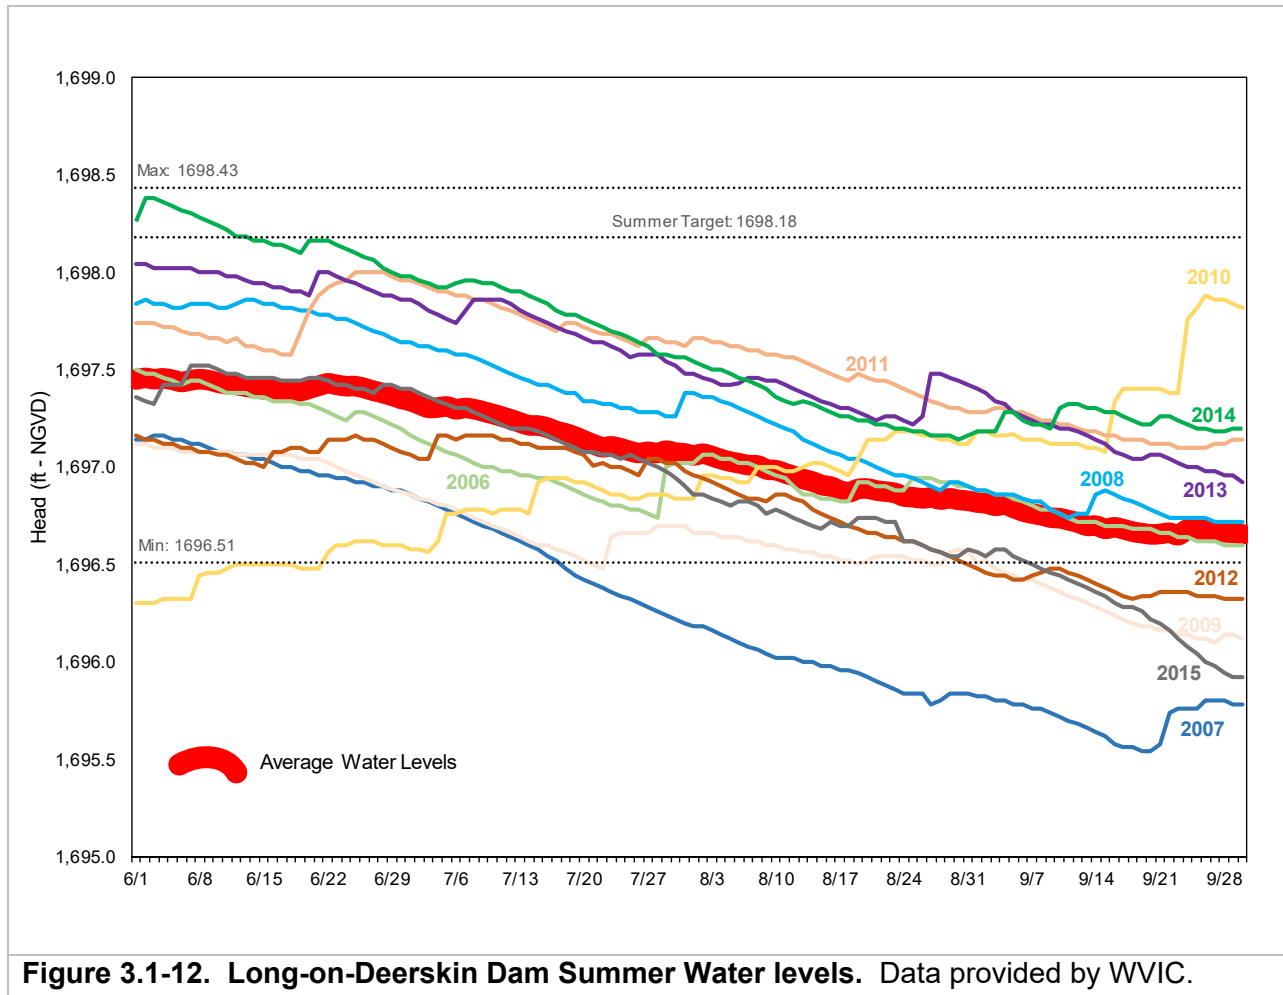
Figure 3.1-12. Long-on-Deerskin Dam Summer Water levels. Data provided by WVIC.

Figure 3.1-12 shows how the past 10 summers compared to the average. On average, water levels drop on Big Sand Lake approximately 0.5 feet between the beginning of June to the end of September. For the most part, native plants grow to the height of the water in which they reside, with only their reproductive structures breaking the surface. But when water levels go down over the course of the summer, the foliage of aquatic plants is now at the water’s surface and can manifest the nuisance conditions.

The summer of 2007 clearly had the lowest water levels. Higher than average summer water levels were observed in 2011, 2013, 2014, and the second half of the summer of 2010.

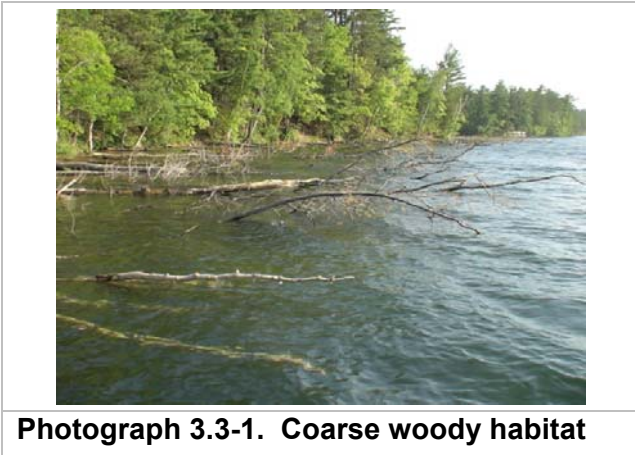
Photograph 3.3-1. Coarse woody habitat

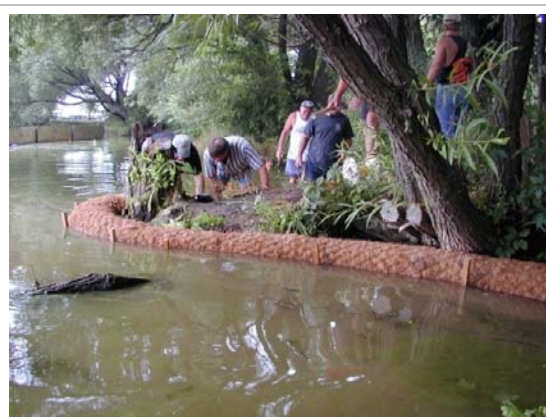
Photograph 3.3-2. Example of a biolog restoration site.

In recent years, many lakefront property owners have realized increased aesthetics, fisheries, property values, and water quality by restoring portions of their shoreland to mimic its unaltered state. An area of shore restored to its natural condition, both in the water and on shore, is commonly called a shoreland buffer zone. The shoreland buffer zone creates or restores the ecological habitat and benefits lost by traditional suburban landscaping. Simply not mowing within the buffer zone does wonders to restore some of the shoreland's natural function.

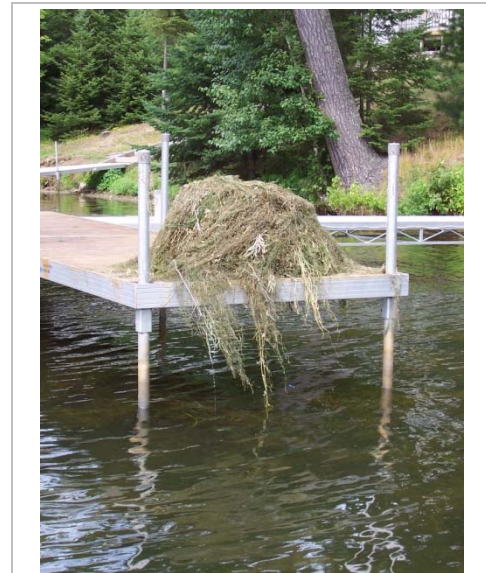
Photograph 3.4-2. Nuisance native aquatic plants. Southern naiad (*Najas guadalupensis*) after being raked from a shoreline.

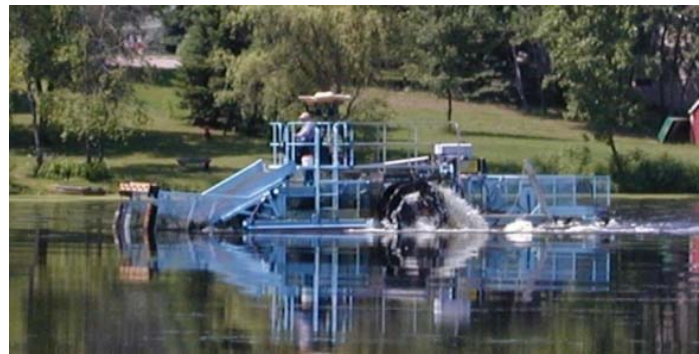
Photograph 3.3-3. Mechanical harvester

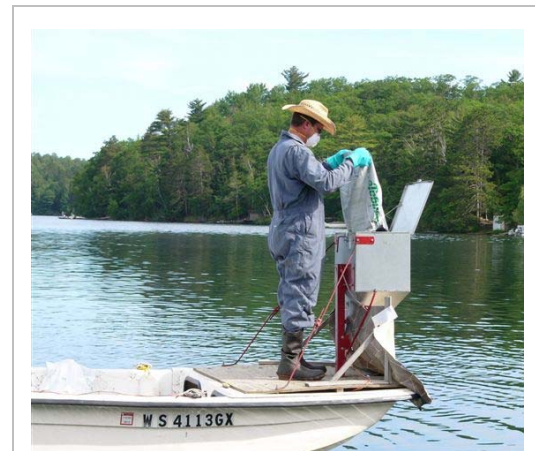
Photograph 3.4-4. Herbicide applicator. Applying granular herbicides with a gravity-fed dispersion method.

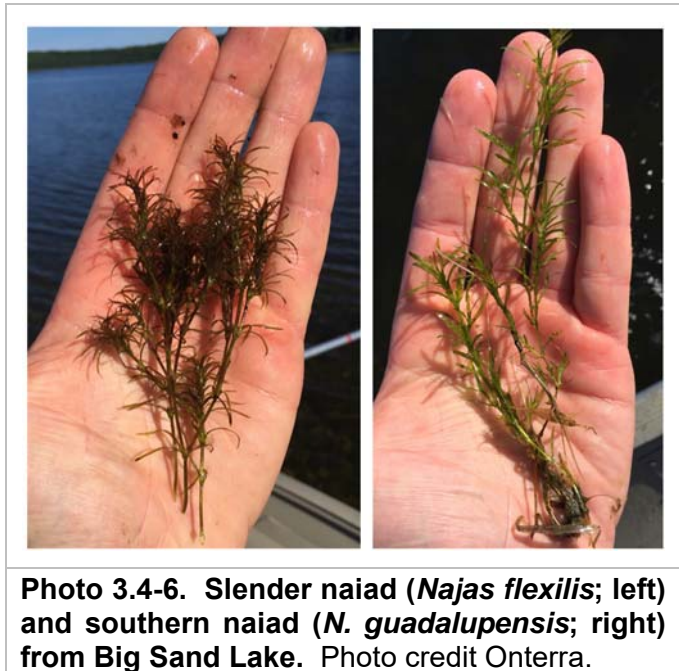
Photo 3.4-6. Slender naiad (*Najas flexilis*; left) and southern naiad (*N. guadalupensis*; right) from Big Sand Lake. Photo credit Onterra.

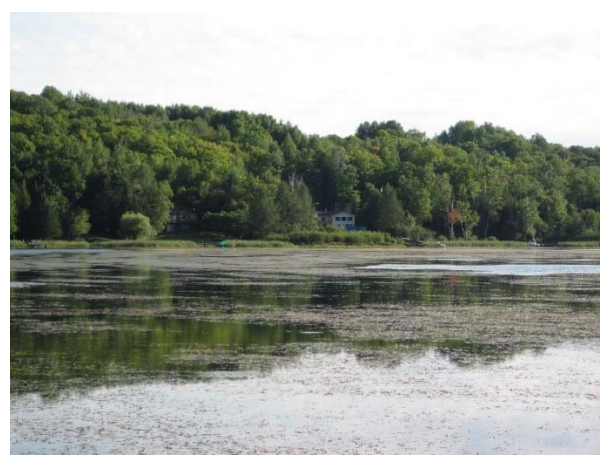
Photo 3.4-7. Surface matted vegetation primarily comprised of southern naiad (*N. guadalupensis*) in the southwestern bay of Big Sand Lake in 2012. Photo credit Onterra.

southwest end has seen a shift from a high occurrence of common waterweed in 2006 to a high occurrence of southern naiad in 2016 (Photo 3.4-7). In 2006, approximately 60% of the 110 sampling locations within this bay contained common waterweed compared to 33% in 2016. Southern naiad was located at approximately 65% of these sampling locations in 2016. However, it is not known if this shift is a result of the herbicide treatments as other area lakes that have not undergone any herbicide treatments are also seeing increases in southern naiad (Susan Knight, personal comm.).

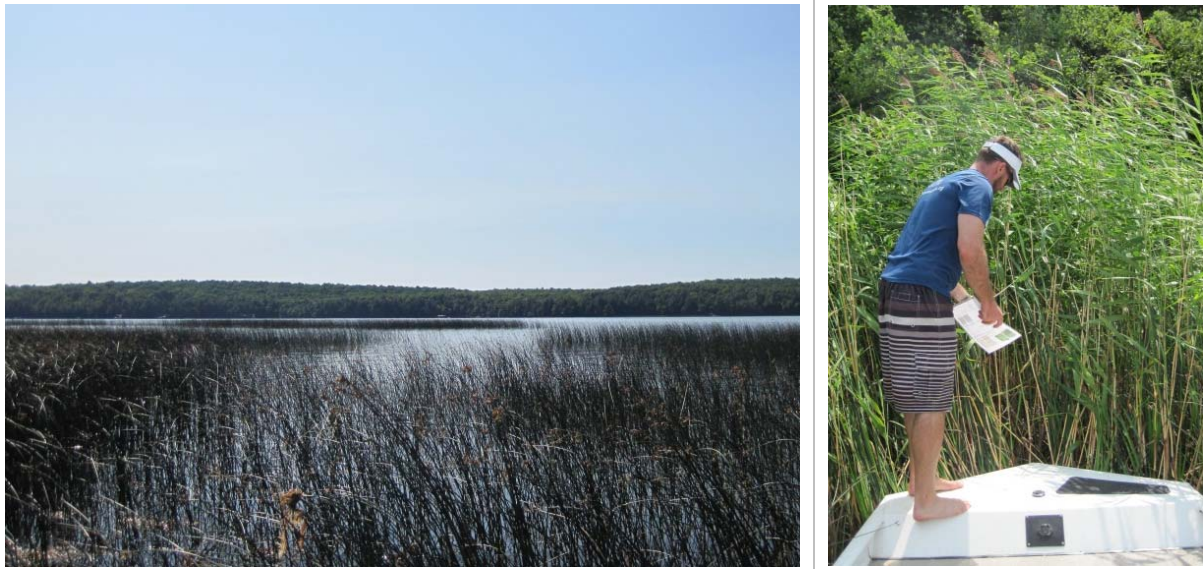
Photo 3.4-8. Expansive hardstem bulrush community along the northern shore of Big Sand Lake (left), and an Onterra staff member inspects a giant reed (native subspecies) colony located on the southern shore (right). Photo credit Onterra.
